## #4 – UNCONTROLLABLE MONSTER

*(System-Environment)*

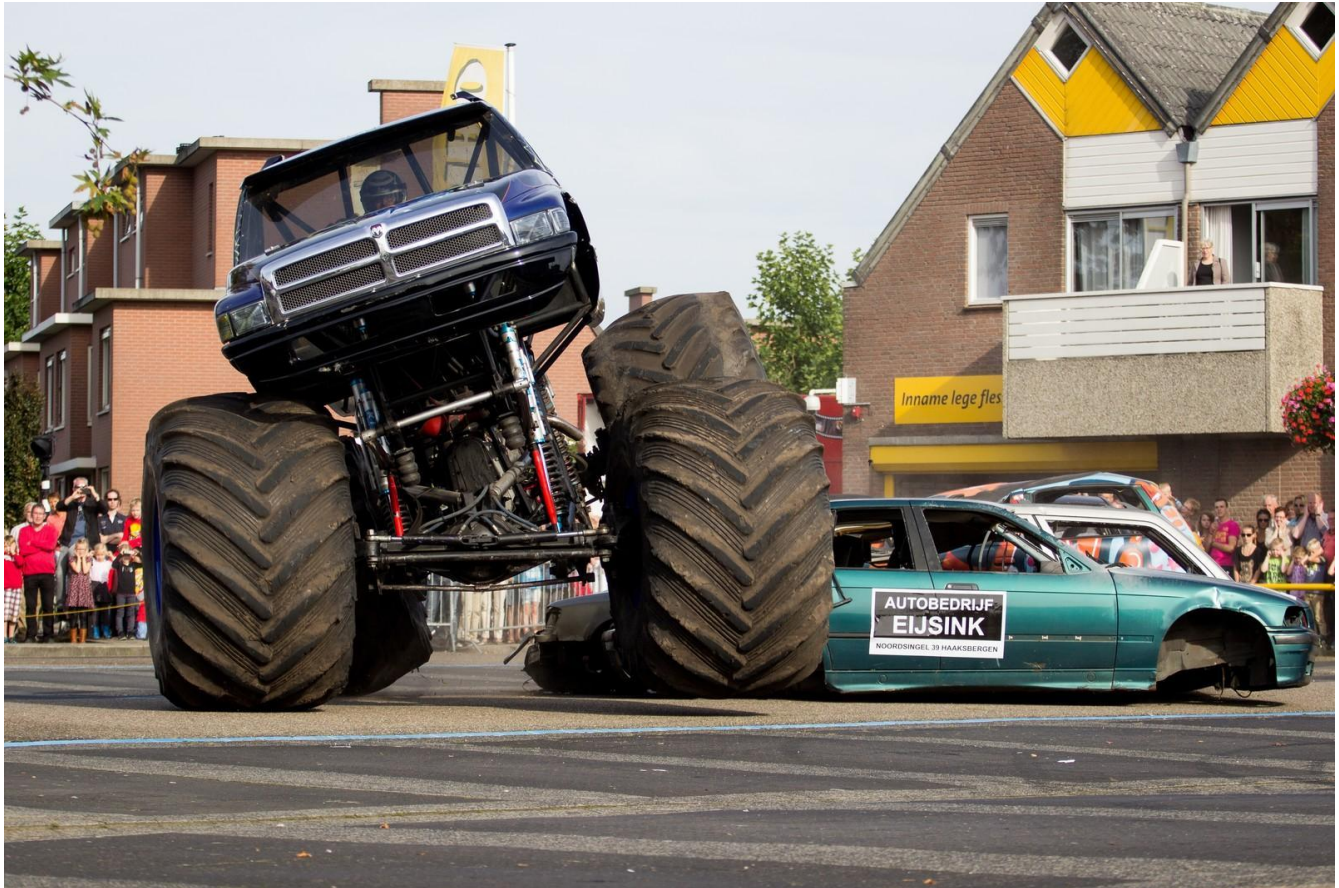
It was September, 2014, AutoMotorSportief 2014 was organizing the monster show; the monster truck was being operated by Mario D. an experienced stunt driver. The show was proceeding smoothly: the monster crossed over a few cars and spectators were amazed by the performance. The truck went again over a few cars; this time, though, whilst coming off them, the monster suddenly jolted forward and took a hard left turn and uncontrollably drove straight into the crowd.

In the investigations carried out, the driver reported that upon descending from the cars he released his foot from the accelerator; however, the clutch seemed to be stuck in place making it mechanically impossible to break and slow down the vehicle. Investigations found out that a piece of glass was stuck in the throttle valve, essentially keeping it open and preventing the clutch from being disabled. This in turn caused an increase in the RPM of the car, which is the reason for the sudden jolt aforementioned. The reason for the loss of control of the car is therefore attributed to this fact; however, the Dutch Safety Board (DSB) reports that the accident, despite the issue with the technical system, could have largely been avoided by the correct implementation of safety guidelines. The overarching factor which contributed to the loss of life and injury of the crowd was their placement and vicinity to the area of performance. The DSB's main argument is that the issue was with the issuance of the permit by the municipality. The DSB states that with issuing a permit, the level of safety must also be assessed and determined in that permit and that the municipality and other issuing bodies bear the responsibility of setting clear safety standards for the hosting organization to abide by. The DSB, based on this statement, determined that too little attention was given to this regard failing to identify the risks associated with an event of this caliber. After all, the only safety measure implemented across the whole show was placing a bike-barrier in between the performance area and the spectators.

Upon issuing a permit for events such as the one at hand, issuing bodies must identify and assess the associated risks first, in order to subsequently impose efficient safety measures. If the level of risk is not assessed, it becomes very easy to overlook certain critical safety factors. Additionally, the primary cause of the accident was the excessively close proximity of the crowd to the performance area. For this matter, it should be noted that a greater distance between the performance area and spectators should be maintained and this safety distance should reflect the magnitude of the stunts to be performed. Events with bigger stunts and therefore greater risk should have a greater separation compared to events with a lower associated risk. Furthermore, having spectators placed on an elevated platform above the performance area would also be beneficial in decreasing the attributed risk. In certain circumstances, having the performance area entirely caged off could be done to even further

reduce the risk. It was also mentioned that glass was found in the throttle valve of the vehicle. It would be useful to perform checks on the cars beforehand and possibly during the show at certain intervals.

In the event that the above measures are not sufficient, then there should be a way to bring the vehicle to an immediate stop. Technology to do so already exists and is widely implemented in most monster truck shows and is called on-board Remote Ignition Interrupter (RII) and allows operators to bring the car to a stop in such events. This device was not implemented in this accident, had it been present, the car could have been stopped and potentially the entire accident could have been halted.
