#5 – BURNING PIPER (Human - System)

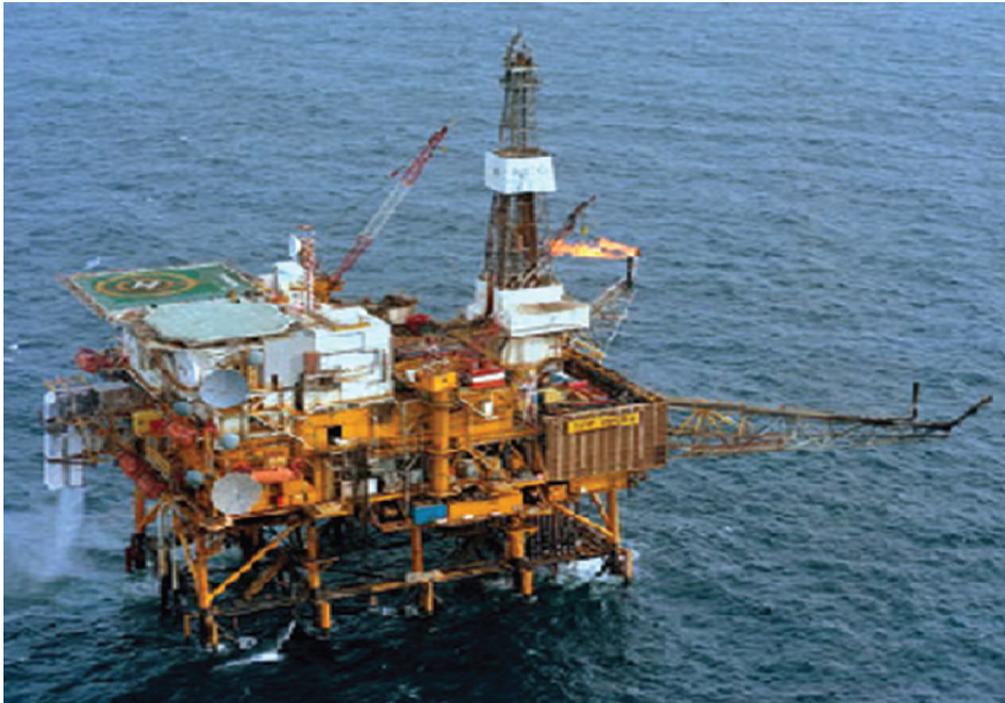
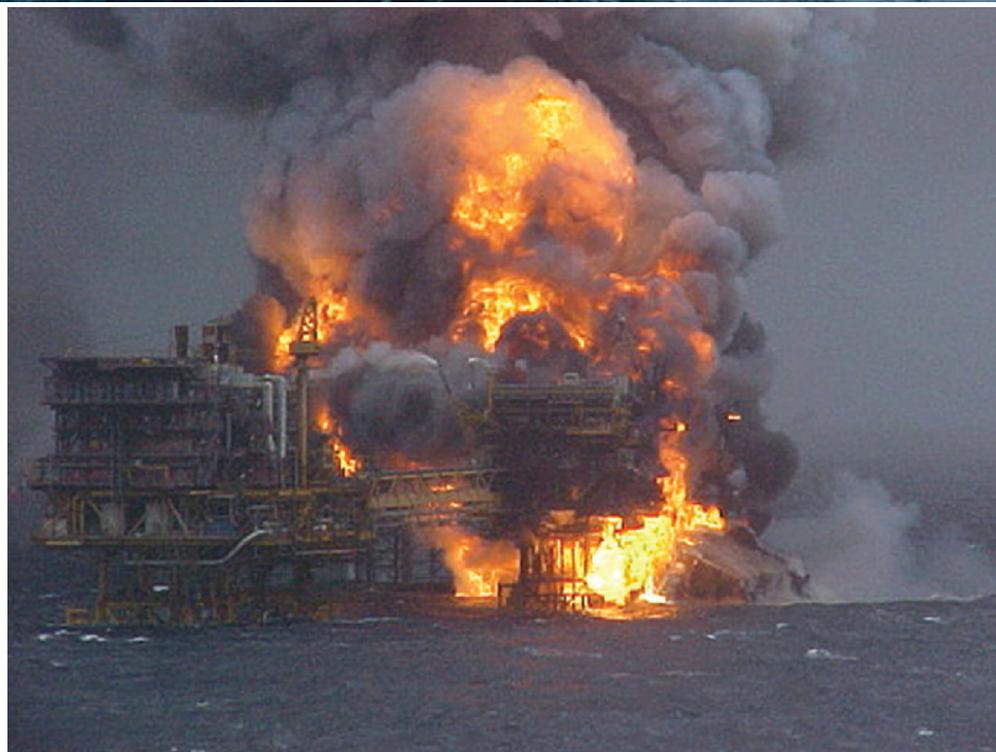
On June 6th, 1988, workers of the day shift performed maintenance operation and Pump A of Piper Alpha had its safety valve replaced by a metal flange. During the night of the same day, Pump B experienced failure due to the accumulation of hydrate. Workers on service that night, in the attempt of solving the issue and wishing to minimize loss of oil production, decided to activate Pump A. Unfortunately, and tragically, night workers were not aware – could not be aware – that only a few hours earlier the safety valve on Pump A had been replaced. Therefore, by activating Pump A, high pressure escaped from the flange and combusted causing a series of explosions.

Following the accident, an investigation was carried out and the root cause of the accident was determined to be the simultaneous work on the pump and safety valve. However, the magnitude of the accident was primarily due to several underlying issues with the design of Piper Alpha itself.
