#3 – ROLLING STONES (Environment)

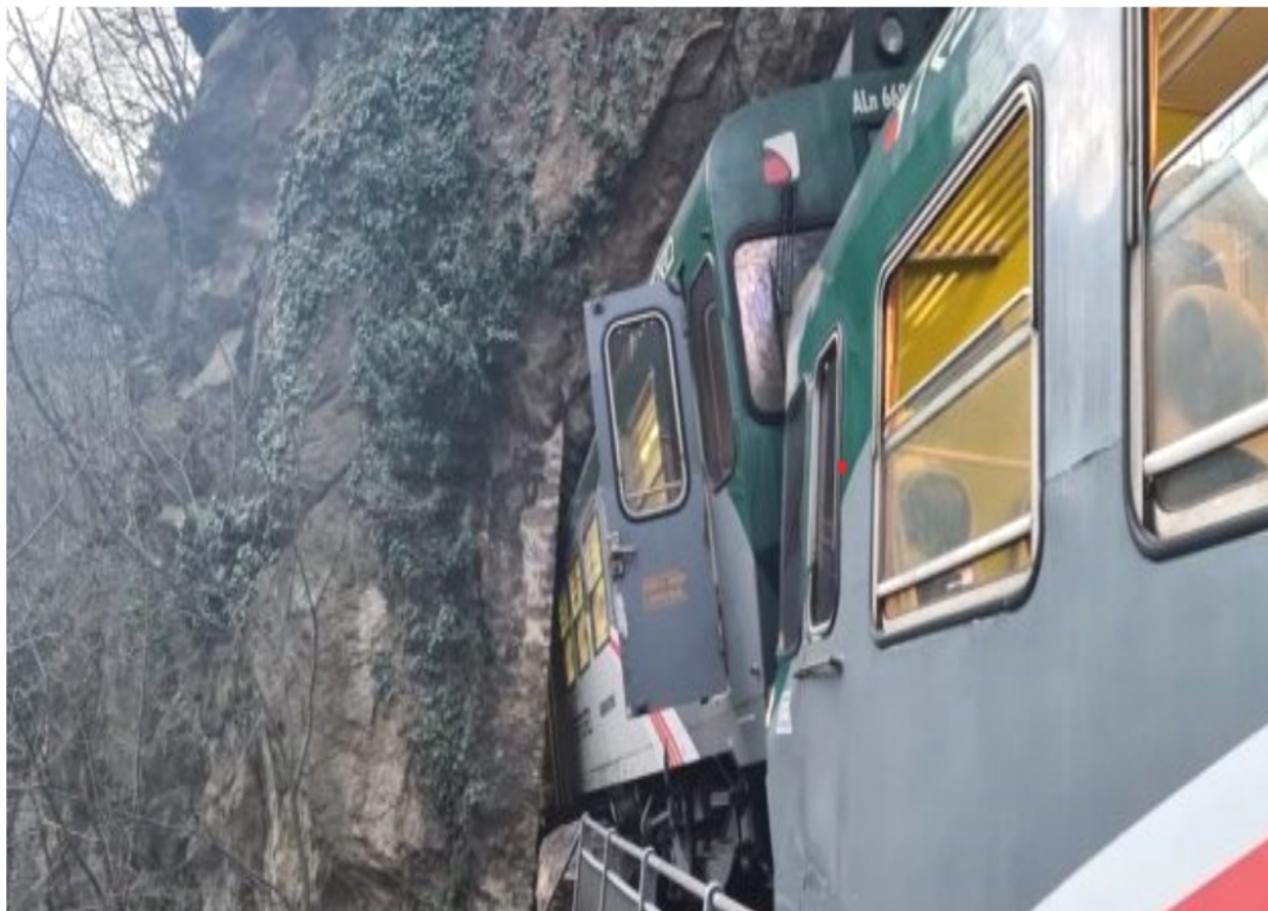
Somewhere in northern Italy, a train line connects the city of Brescia to Edolo, a little town in the Alps. The train track runs across a mountainous area, at times following the profile of the rocks, at times crossing tunnels. On December 1st, 2012, the service was running as smooth as usual, until the train wagons crashed against a boulder on the rails. Not many passengers were on board at that time, and luckily none of them suffered major injuries.

Investigations which followed the accident explained how this boulder had detached itself from the side of a mountain adjacent to the railway and upon falling ended up on the train track causing the accident.

Despite the use of technology presented above, accidents can still occur and secondary preventive measures should always be in place to further decrease the risk. For rockslide prevention/mitigation, there are a few options that can be used. *Wire Meshing* is commonly used for such practices and is placed along and around the mountain to capture any debris falling down. *Retaining walls* can also be used and are placed at the base of the mountain and stops debris that have fallen off and prevents them

from being on roads or other infrastructure. *Soil nailing* is another option whereby steel rods are drilled into the soil of the mountain and increases its cohesion ability making it less susceptible to rockslide. These are all different options which are already implemented and in the case at hand, if present, could have made a significant difference in the outcome of events and drastically reduced the level of danger presented by the environment.
