#1 – CAPSIZING BARGES (Technical)

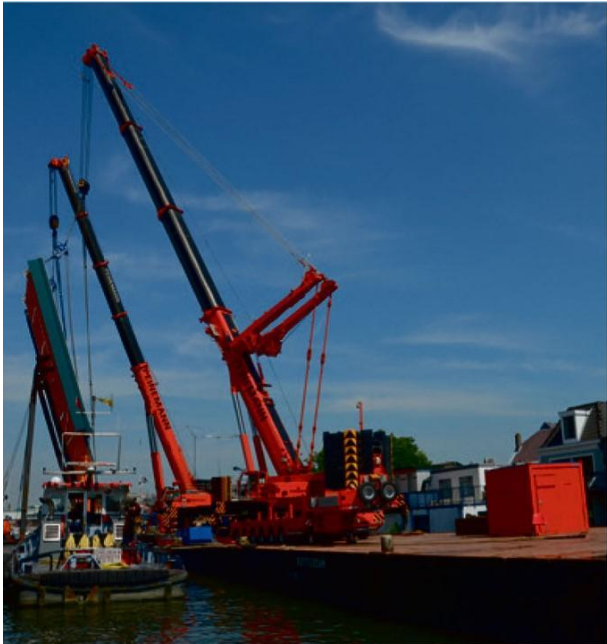
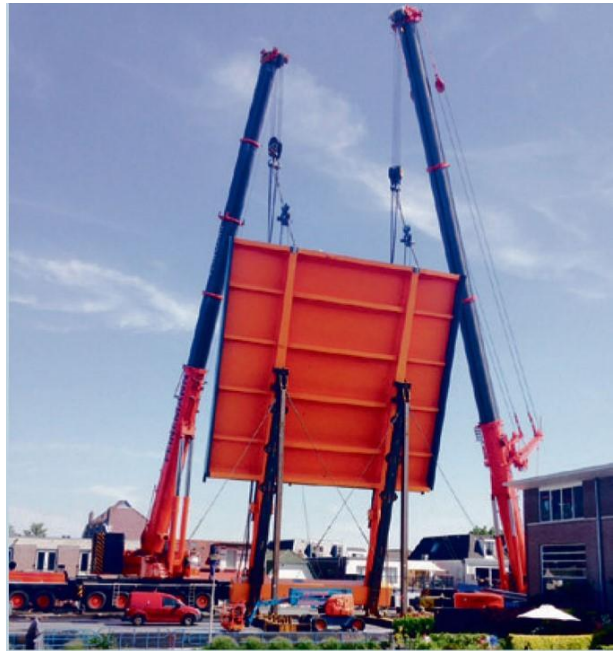
The entire configuration of the system included 3 barges; two of them had cranes mounted on top and were used to suspend and transport the new section of bridge to be installed. The third barge had the actual section of bridge that needed to be picked up by the other two. The two barges looked identical... however they were not! One of them was carrying a larger crane compared to the other which was slightly smaller in size and height. The two cranes slowly began lifting the bridge into the air, the operation seemed smooth with no visible problems to be noticed. Anyhow, once the bridge was fully suspended in the air by the cranes, it started swaying and swinging towards the smaller crane. The section of bridge was now moving in a dangerous, uncontrolled manner forcing both crane operators to evacuate from the cranes promptly. What happened next is unfortunately easy to imagine...both barges capsized leading to the overall failure of the entire technical system.

For lifting rigs, stability is a fundamental requirement to avoid accidents and damage. A key parameter for lifting rigs and floating objects is the "Metacentric height" (GM/initial stability). GM is mainly affected by:

- Height of the combined center of gravity (COG) of the barge and elements on it
- The width-depth ratio of the barge

A higher GM is favorable and indicates greater stability of the barge. Typically, you want a GM above 1 to ensure sufficient stability. A GM near zero results in a very unpredictable response of the system whereas a GM with a negative value will most likely capsize. In complex and dangerous processes such as these, often a minimum GM requirement for safe procedure is formulated. This was also indeed done in this case, the barge operator prior to beginning had established that the GM of 2-2.5 was sufficient for the stability of this operation.
